Meat&Doria **805161**
Hoffer Products **H805161**

FOCUS

Transmission Components

Introduction

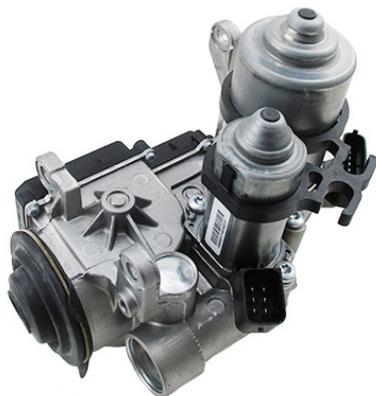
Replacement Gear Selector Module (cod. 805003)

It is an electromechanical module that replaces the driver's manual control in an automated manual transmission.

Automation: It receives electrical impulses from the transmission control unit and converts them into mechanical movement.

Gear selection: It physically moves the selectors inside the gearbox to engage the correct gear or neutral, without the driver having to use a mechanical lever or clutch pedal.

It is used to repair common faults where the transmission remains stuck or does not respond correctly to commands.

- Detects the gear lever position (P-R-N-D-M/S)
- Sends the signal to the transmission control unit
- Enables engine start authorization in P or N
- Manages manual or sport modes when present

- Under the gear lever (in traditional systems)
- Integrated into the central tunnel
- In electronic shift-by-wire systems, it is fully electronic
- Mounted on top of the gearbox (at gear engagement and selection mechanism)

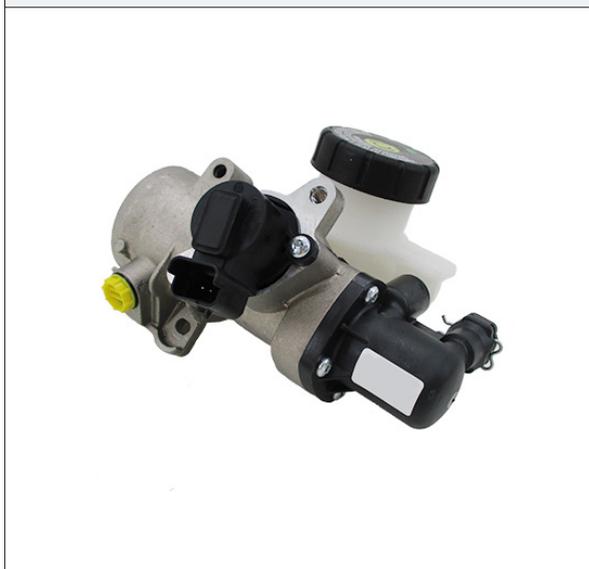
Central Clutch Slave Cylinder (CSC) (cod. 805026)

It is a fundamental hydraulic component of the automatic/automated transmission control unit.

Automatic disengagement: It receives hydraulic pressure from the valve body to physically push the clutch pressure plate.

Pedal replacement: It performs the function that, in a manual car, the driver would perform by pressing the clutch pedal, allowing the control unit to disengage the transmission and change gears autonomously.

- Converts pedal pressure into mechanical movement
- Pushes directly on the clutch pressure plate
- Allows clutch disengagement for gear shifting

In modern systems replaces the traditional external slave cylinder with fork

- Inside the gearbox bell housing
- Mounted around the input shaft
- Integrated into the release bearing assembly

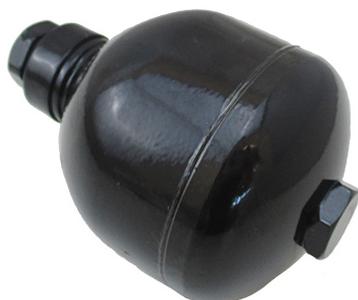
Pressure Accumulator (cod. 805038)

A pressurized metal shell filled with nitrogen and containing a movable separator element, typically with nitrogen gas on one side and hydraulic oil on the other. It stores hydraulic energy for the transmission actuation system.

Energy storage: The transmission electric pump sends oil into the accumulator, compressing the nitrogen inside. This maintains a reserve of high-pressure oil ready for use.

Shift speed: Thanks to stored pressure, the system can operate the clutch and shift gears instantly without waiting for the pump to start each time.

- Stores hydraulic pressure
- Stabilizes the circuit
- Ensures energy reserve for actuators (transmission, clutch, suspension, etc.)
- Reduces pressure fluctuations

Usually cylindrical or spherical in shape

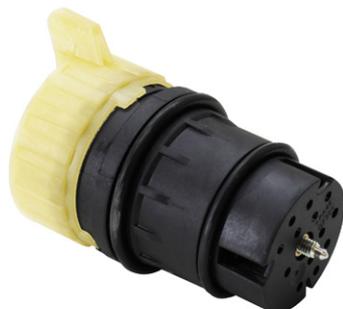
Automatic Transmission Connector Housing / Control Unit (cod. 805122)

A 13-pin plastic connector with seals that serves as the connection point between the vehicle's external wiring harness and the internal electrical plate of the transmission.

Data transmission: Allows the transmission control unit to communicate with internal sensors and solenoids to manage gear shifts.

Sealing: Its seals must prevent transmission oil leaks.

Common issue (capillarity): If the seals fail, transmission oil can travel by capillary action along the wiring up to the control unit, damaging it.

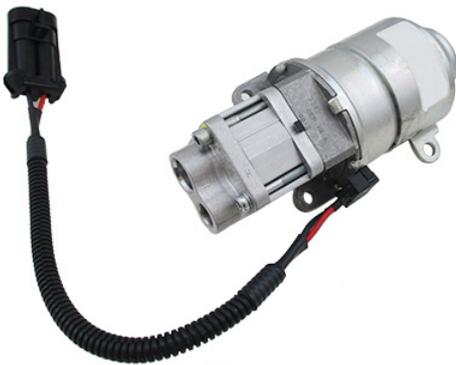
Automated transmission electric pump (cod. 805046)

It is the energy core of the hydraulic system that manages the transmission. It is a small electric motor coupled with a pump that generates the pressure necessary for actuator operation.

Pressure generation: When opening the vehicle door or switching on the ignition, a buzzing sound is heard: it is this pump activating to pressurize the oil in the hydraulic circuit.

Actuator supply: The pressurized oil is sent to the actuators that physically move the clutch and gears. Without the thrust of this pump, the transmission cannot perform any operation.

- The control unit detects a drop in pressure
- Activates the electric pump
- The pump pressurizes the circuit
- The accumulator stores pressure
- The actuators use the pressure to change gear

It activates at intervals to maintain stable pressure.

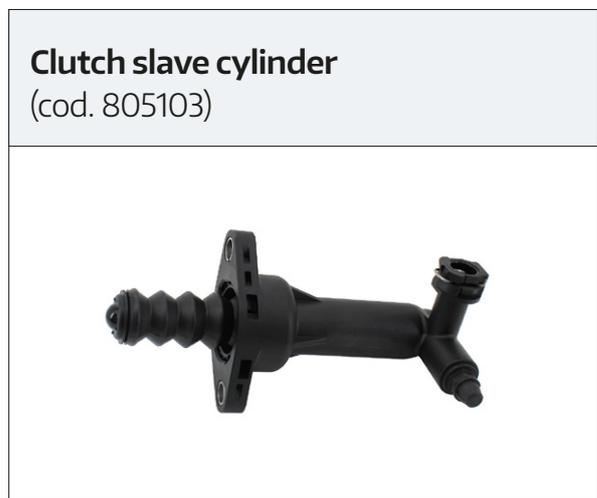
It is a hydraulic component of the clutch disengagement system, usually made of high-strength plastic material or metal.

Pressure conversion: With the pressure of the clutch pedal, the master cylinder sends hydraulic oil (brake fluid) to the secondary cylinder.

Mechanical action: The fluid pressure moves a piston inside the small cylinder, which in turn pushes the rod to move the clutch pressure plate and temporarily disconnect the engine from the transmission.

- Receives hydraulic pressure from the master cylinder
- Transforms pressure into mechanical movement
- Operates the clutch fork
- Allows clutch disengagement

- Outside the gearbox bell housing
- Fixed on the gearbox housing
- Connected to the clutch fork via push rod

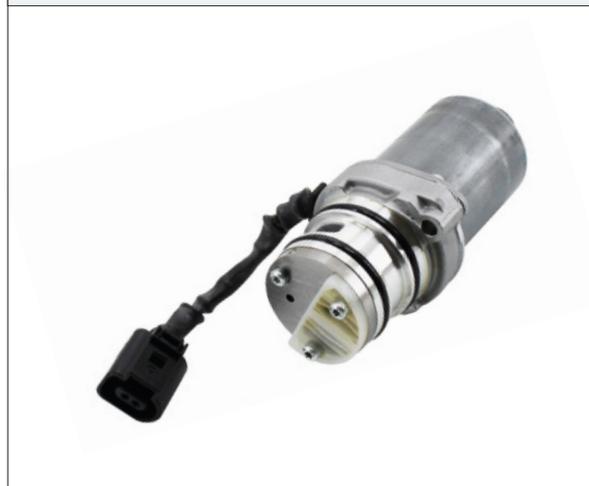
Multi-plate coupling pump
(cod. 805127)

The Haldex coupling, used in all-wheel drive vehicles, allows management of different torque values between the two axles, continuously varying the percentage sent to the front and rear wheels.

It consists of a **cylindrical housing** that contains two sets of plates, one connected to the front axle and the other to the rear axle, which form the electrohydraulic multi-disc clutch pack managed through electronic control.

The clutch is of the **oil-bathed multi-disc type** and the pressure with which the plates are pushed together determines the amount of torque transferred between the axle connected to the engine and the axle that engages in case of loss of traction.

Under normal driving conditions the Haldex clutch is open; therefore, **the two axles are independent**. If, however, the ABS wheel speed sensor detects that the front axle rotates faster than the rear one, the control unit activates the hydraulic pump, which, by increasing the oil pressure in the actuators, brings the two clutch sectors closer together, tightening the clutch pack and consequently allowing **torque transfer between the two axles** thanks to the increased friction between the plates.

- Integrated into the rear differential
- Connected to the driveshaft
- Includes: multi-disc clutch, hydraulic pump, control unit and sensors
